Polymer Matrix Composite Lines and Ducts

(National Research Announcement 8-21 Final Report)

A. T. Nettles

Marshall Space Flight Center, Marshall Space Flight Center, Alabama

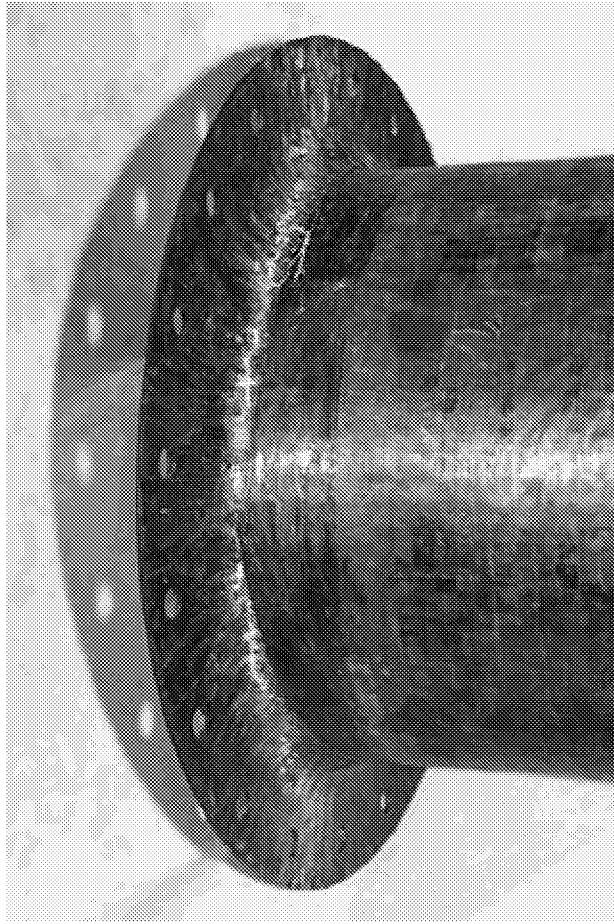
Figure 11. View of flange area of a feedline manufactured via TTL.

Figure 10 shows a completed feedline manufactured by TTL. A closer view of the flange area is given in figure 11. This area is particularly rough with obvious areas of nonconsolidation visible from the surface. This was of great concern since it could facilitate leaks and compromise the structural integrity of the feedline. A view of the microstructure in the acreage of the feedline is given in figure 12. Poor consolidation with large areas of delamination can be seen. The thermoplastic tape apparently was difficult to compact by the robotic head.

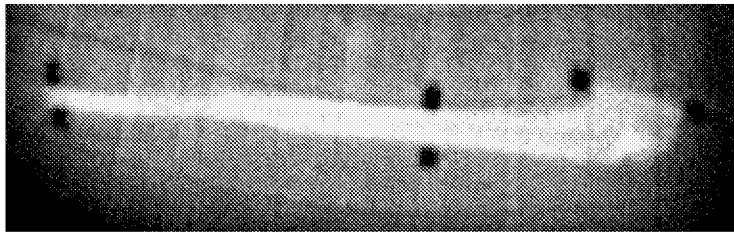
Figure 13. Flash thermography image showing foreign object (plastic tape) inclusion.

The feedlines were inspected using flash thermography, an NDE technique. Flash thermography consists of hitting the test article with a pulse of heat and then monitoring the release of the heat with an infrared camera. Areas that have anomalies will give off heat at a different rate than the rest of the tube, thus identifying the location and general shape of possible defects. A sample picture of a thermography image is shown in figure 13. In this figure, it can be seen that an anomaly appears (which turned out to be plastic tape).

The dark spots around the perimeter of the defect in figure 13 are foil markers used to help identify locations on the thermograms. Each test article was marked off with an array of foil markers as shown in figure 14. This produced a grid pattern so each thermogram could be identified. For example, the dark gray shaded area in figure 14 would be designated “position B2” and the light gray shaded area “position E12.” Due to the bend in the article, there is a smaller distance between the flanges along the inside radius of the tube; thus, there are only 11 areas along the inside radius versus 13 areas along the outside radius. A sample thermogram with no anomalies is shown in figure 15.

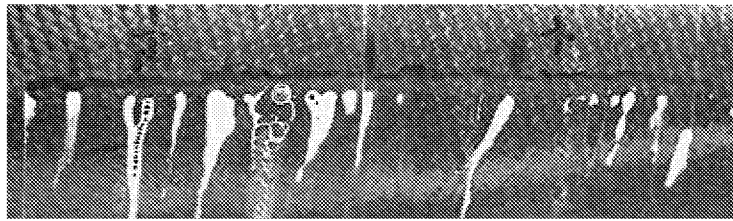
Figure 16. Leak as detected by bubble-type solution in a test article.

Once proof testing was completed, the next series of tests performed were leak checks at 50 psi using gaseous helium (GHe). The test article was enclosed in a bag (excluding the flange bolts and seal joint) to capture any GHe leaking through the parent material. A probe connected to a helium (He) mass spectrometer was inserted into the bag to sense for any He leakage. The test article sat for 10 min before a leakage reading was recorded. If leaks were found, the test article was set aside and not used for cryogenic testing. The tubes with leaks were taken to the damage tolerance facility in MSFC's PEC and examined further to determine the possible cause of the leaks. Figure 16 shows a bubble-leak detect solution being applied to one of the test articles manufactured by HLU. In this particular feedline, a line of small leaks was apparent.

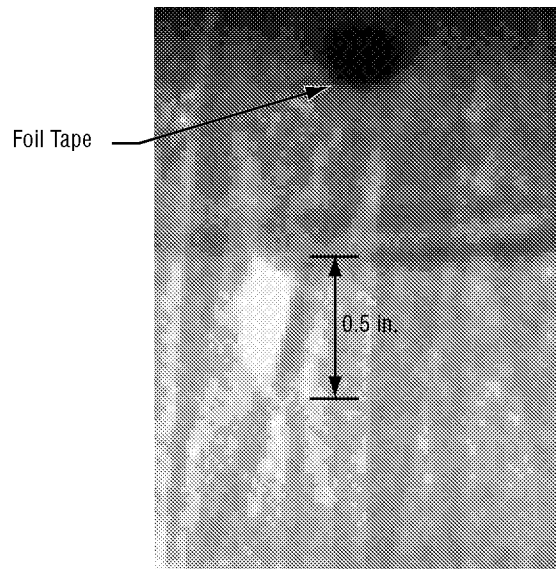
Figure 18. Anomaly noted on thermograph of feedline HLU-2.

Eight HLU feedlines that were autoclave cured were inspected using flash thermography. Feedline HLU-1 showed no anomalies. For feedline HLU-2, only one major indication was found. The abnormality appears hot (white) which would indicate a void or inclusion of some material that blocks the flow of heat into the tube. The thermogram for this anomaly is given in figure 18.

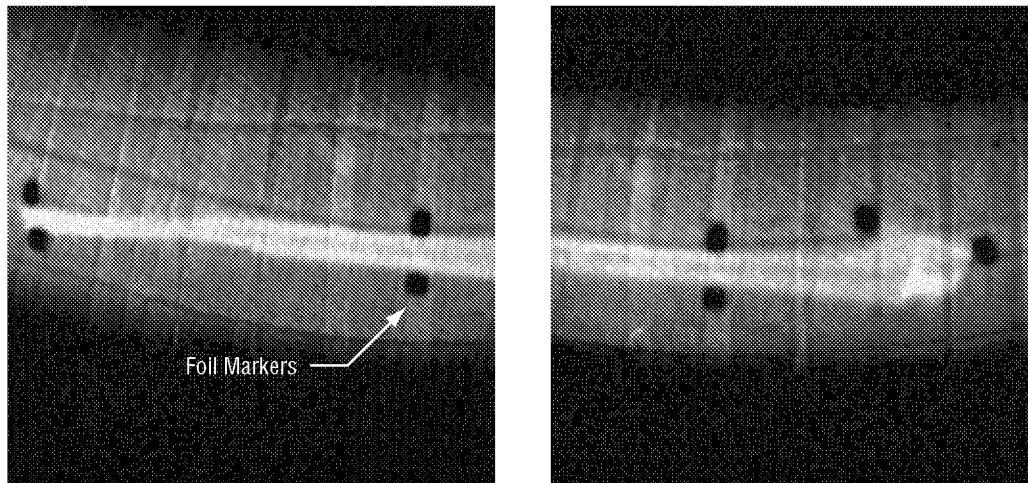
Figure 19. Large inclusion found on feedline HLU-3.

A large inclusion was found on the inner radius of feedline HLU-3. The thermographs are shown in figure 19. Since this anomaly was so large, the feedline was scrapped for subsequent testing. This provided an opportunity to dissect the feedline to determine the cause of the anomaly. Upon sectioning, it was found that the anomaly was a piece of plastic tape under the innermost ply of prepreg. This can be clearly seen in figure 20.

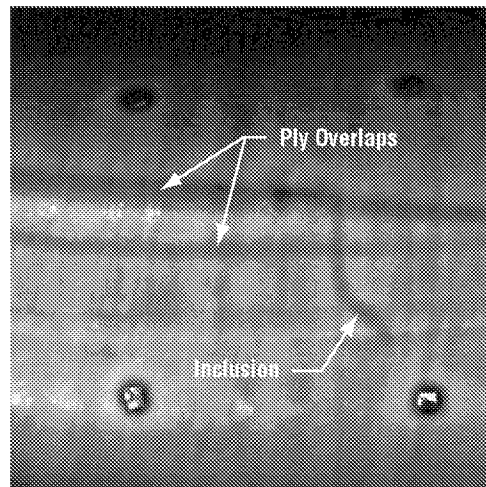
Figure 21. Dark regions and anomaly found in tube HLU-4.

In feedline HLU-4, dark bands found throughout the acreage of the tube (both circumferential and axial), most likely indicate ply overlaps and resin pockets. In figure 21, these dark bands are illustrated along with an inclusion. A delamination was found below a ply splice in the tube acreage. Visual inspection of the region found a surface crack along the upper edge of the indication at the ply splice.

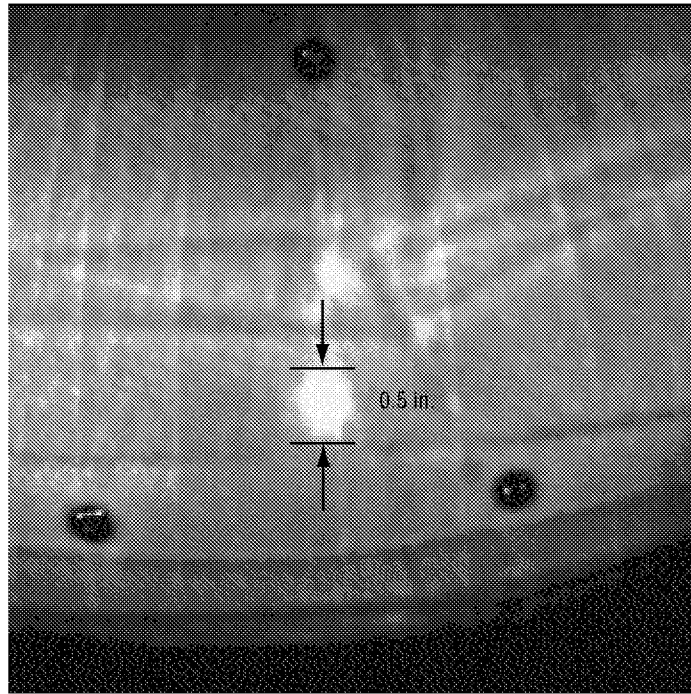
Figure 22d. A bump is visible on the surface indicating an inclusion with possible internal void.

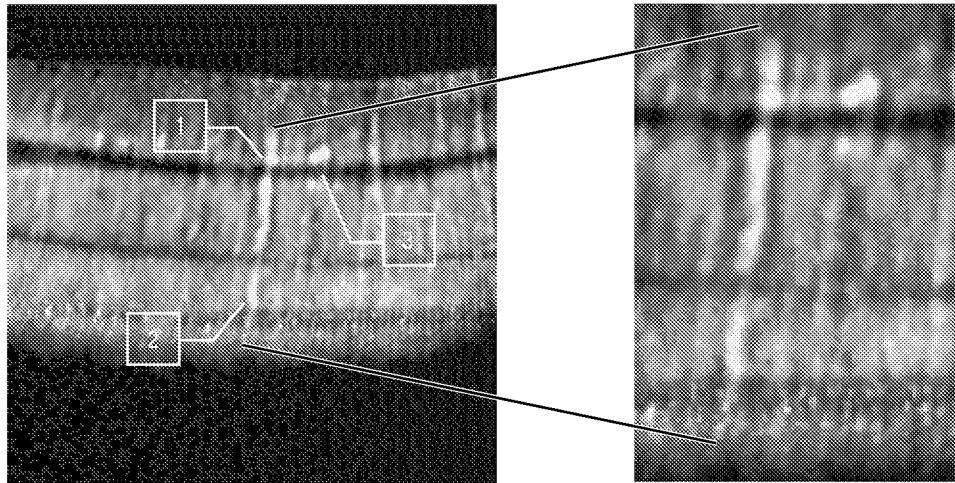
Figure 23. Anomalies on feedline HLU-6.

For feedline HLU-6, indications 1, 2, and 3 in figure 23 appear on the surface as small bumps and may be inclusions or ply wrinkles with embedded voids.

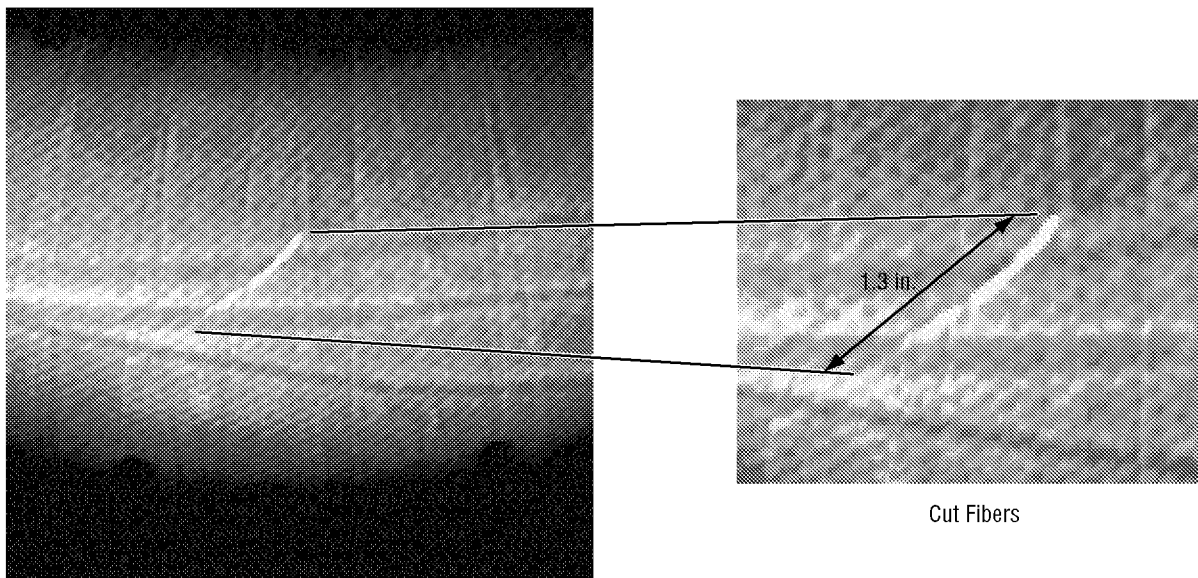
Figure 24. Thermography image of scuff on feedline HLU-7.

Feedline HLU-7 appears to have been scuffed and the indication shown in figure 24 is visible as a scratch with exposed fibers. In addition, on feedline HLU-7, a faint surface ripple is visible, indicating a deeply embedded inclusion. The thermograph is shown in figure 25.

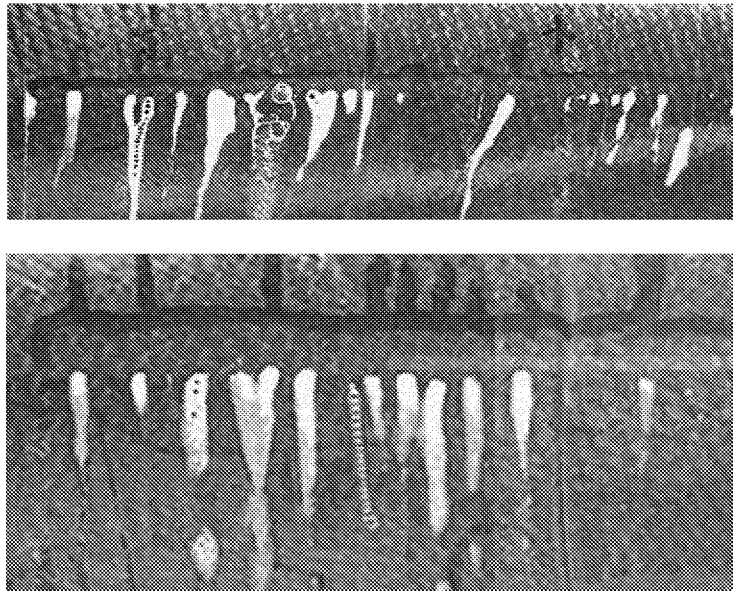
Figure 30. Two areas of pinhole leaks on feedline HLU-5.

Of the eight test articles manufactured by HLU, two leaked prior to cryogenic testing. Feedline HLU-5 had two areas of linear pinhole leaks and feedline HLU-6 leaked at several sites. Figure 30 shows the two areas of linear pinhole leaks in feedline HLU-5. The tube was pressurized with 20 psi of GHe and a leak detect solution was squirted on the outside. The resulting trail of very small bubbles indicates very small leaks.

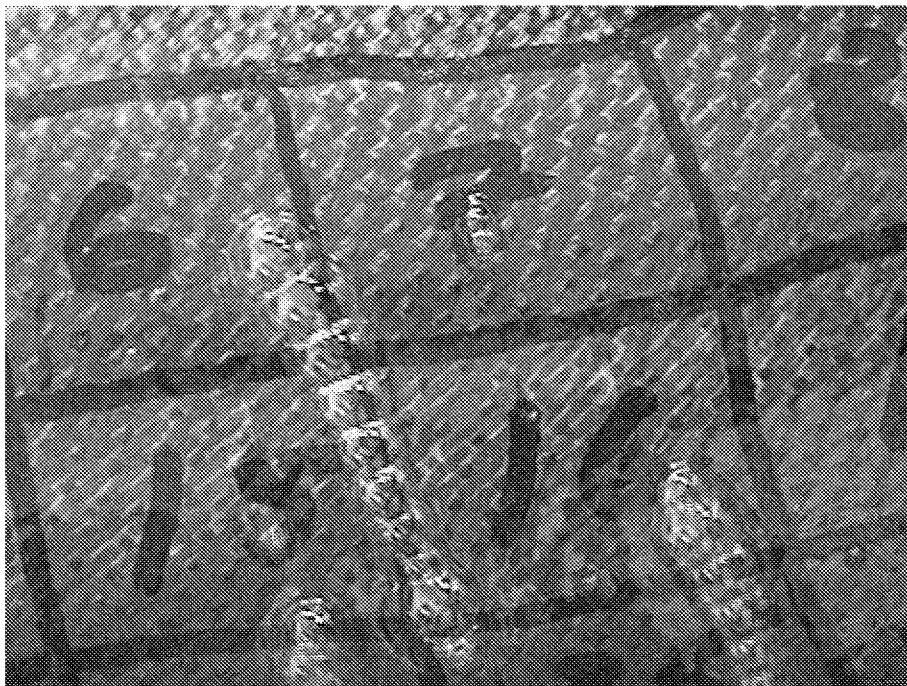
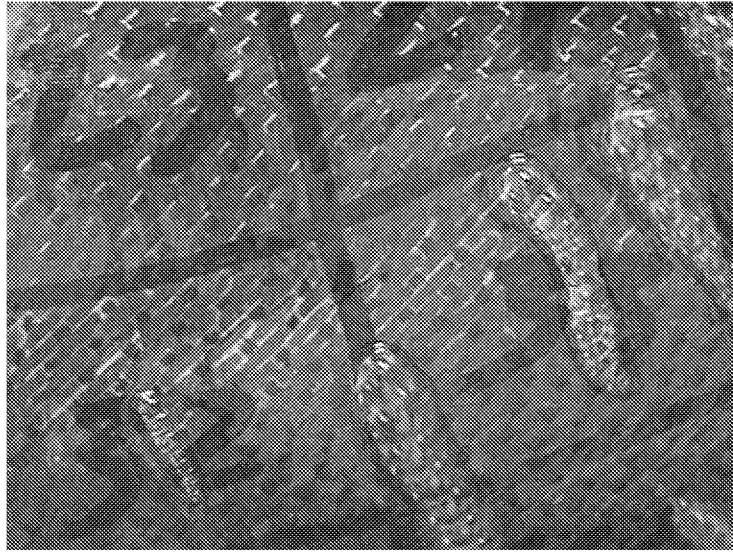
Figure 31. Samples of leak areas on feedline HLU-6.

Figure 31 shows some of the leaks on feedline HLU-6. Note that these leaks form larger bubbles than those on feedline HLU-5 (as shown in fig. 30). This indicates larger “holes,” as does the fact that the pictures in figure 31 were taken with the tube at only 3.5 psi. The area of leaks on feedline HLU-6 was marked off into a grid pattern with each grid numbered so the leaks could be better identified.

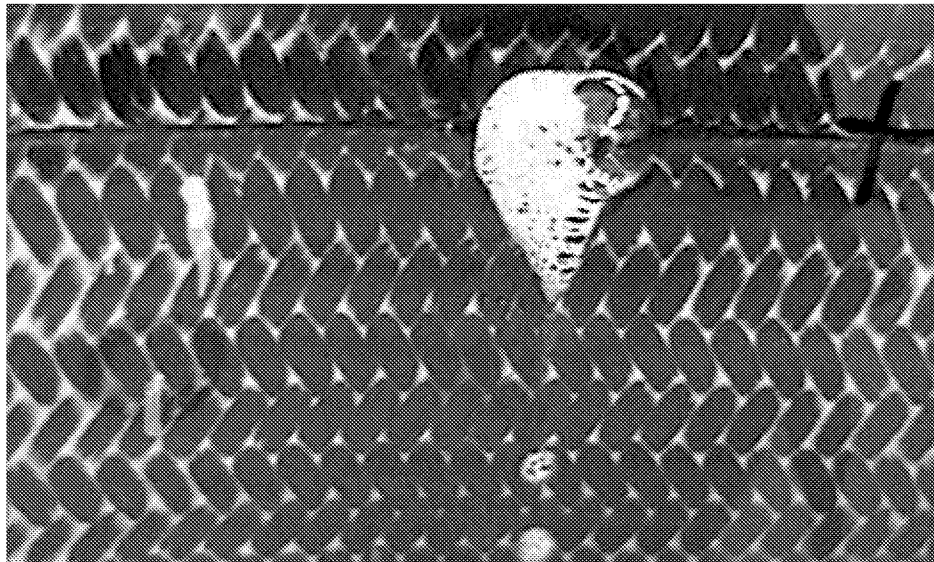
Figure 32. Feedline SARTM-1 showing three leak paths.

Of the four feedlines manufactured by SARTM, two leaked prior to cryogenic testing. Feedline SARTM-1 demonstrated three areas of leakage and feedline SARTM-3 showed one area of leakage. Figure 32 shows the three leaks in feedline SARTM-1. One of the leaks is large compared to the other two. The feedline was pressurized at 5 psi when the photograph was taken.

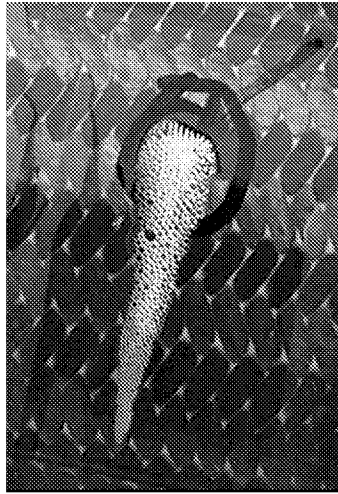
Figure 33. Feedline SARTM-3 showing one large leak path.

Figure 33 shows the one leak found in feedline SARTM-3. Due to the large size of the bubbles, the leak is significant. The feedline was pressurized at 2.5 psi when this photograph was taken.

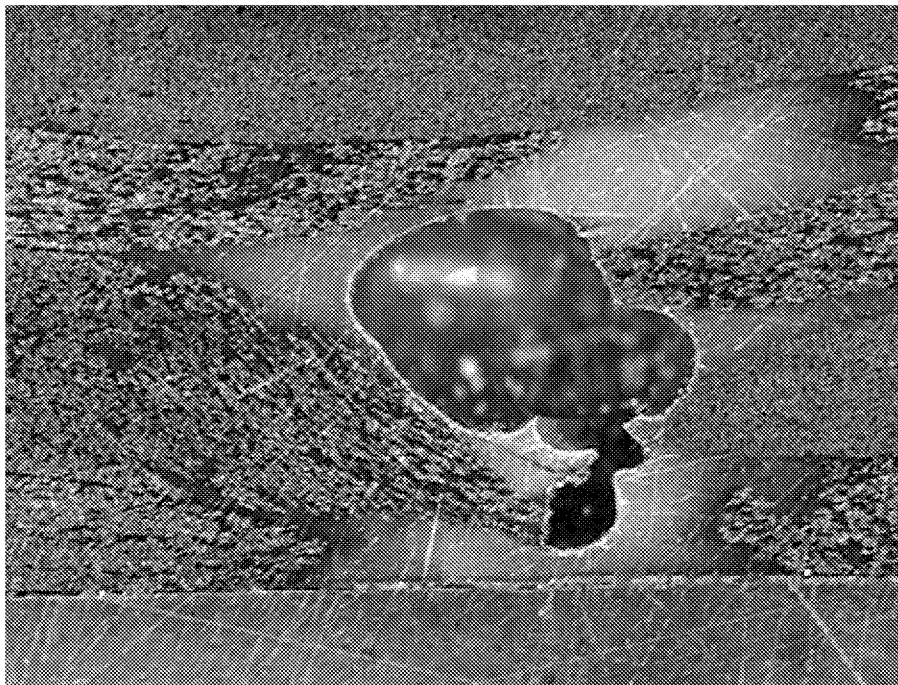
Figure 34. Cross section of leak area on feedline SARTM-1.

Since these feedlines would not undergo any further testing, they were sectioned at the areas of leakage and photomicrographs taken. Figure 34 shows the cross section of feedline SARTM-1 in which an air bubble appears to be responsible for the leakage seen. Figure 35 shows the cross section of feedline SARTM-3. A small region of the preform is resin starved and provided the large leak path seen.

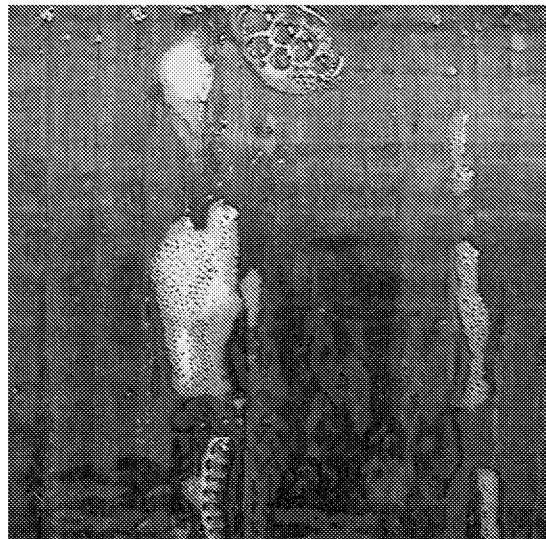
Figure 36. Feedline TTL-2 showing ring of leakage around flange buildup area.

Four feedlines manufactured via TTL were leak tested. All four feedlines showed leakage around the flange buildup area. Figure 36 shows the leakage on feedline TTL-2. The feedline was pressurized at 5 psi for these leak tests. Some of the leaks are very small while others are larger as evidenced by the larger bubbles forming.

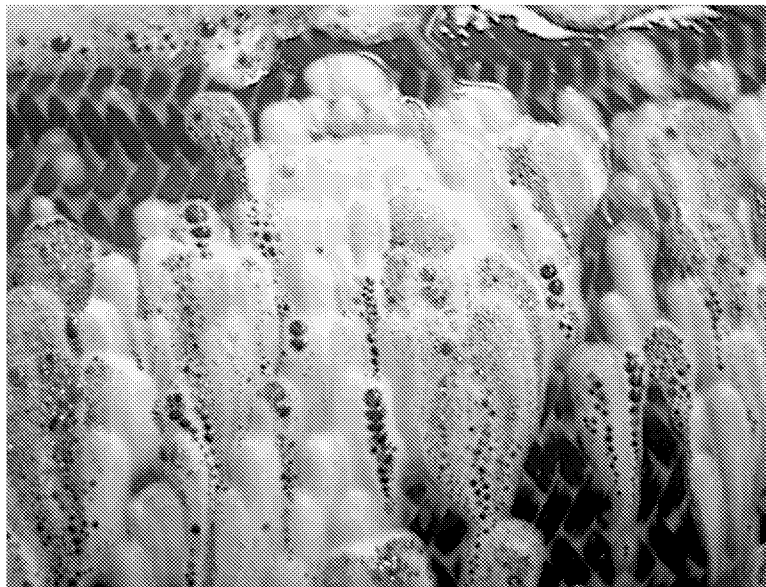
Figure 39. Leakage across feedline SARTM-2 after first introduction of LN_2 into the feedline.

SARTM-2 was the first feedline of this type to be tested. During the first cryogenic cool-down cycle with LN_2 , strain gauge readings were being lost. Upon closer inspection, it was noted that LN_2 was pouring out from the insulation around the feedline. The insulation was removed and it appeared that the LN_2 was seeping out of the tube across its entire acreage. The cryogenic testing was stopped and a GHe leak check was performed. The feedline was filled with 10 psi of GHe and a leak detect solution was sprayed over the feedline. Leakage was observed over the entire area of the feedline. Figure 39 shows the extent of the leakage on this tube. Feedline SARTM-4 was then filled with LN_2 and yielded the same results as feedline SARTM-2. Cryogenic testing on these feedlines was terminated at this point.

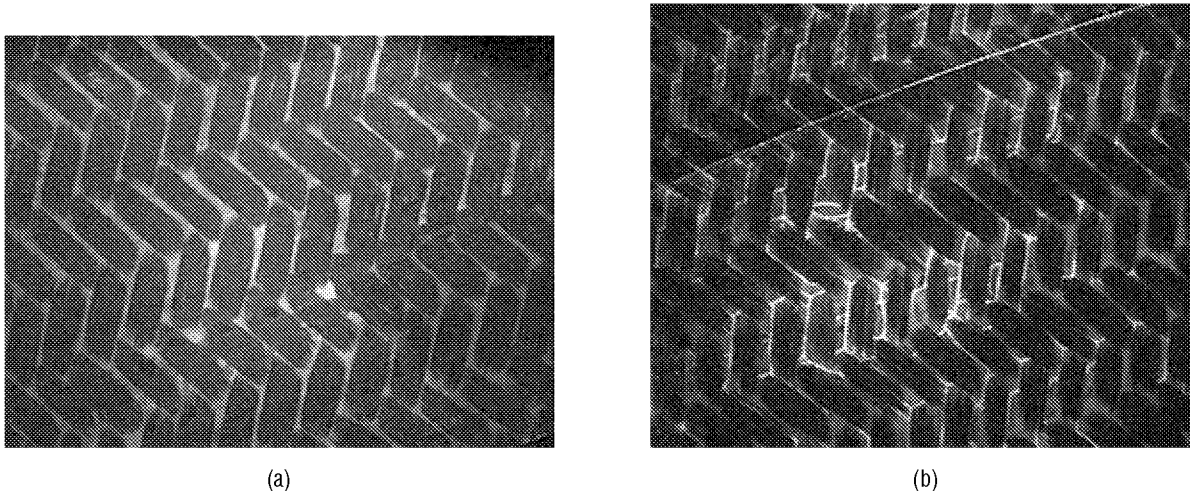
Figure 40. Inside surface of SARTM feedlines: (a) No cryogenic temperature and (b) LN₂ temperature excursion.

Feedline SARTM-2 was then dissected for inspection as to the mechanisms behind this gross leakage. Figure 40 shows a view of the inside surface of the tube after a UV dye was placed on the surface. For comparison, a SARTM tube that did not undergo cryogenic testing is also shown. Many matrix cracks can be seen on the specimen that saw one temperature drop to LN_2 temperature.

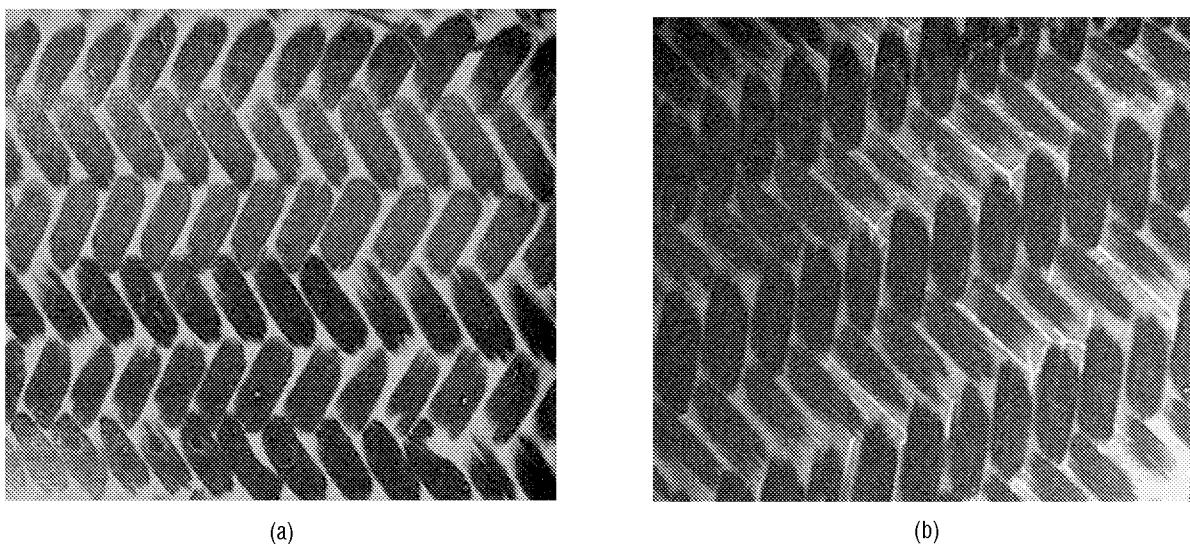
Figure 41. Outside surface of SARTM feedlines: (a) No cryogenic temperature and (b) LN₂ temperature excursion.

Figure 41 is a view of the outside of a SARTM feedline that saw a temperature drop to LN₂. A section of a SARTM feedline that did not experience cryogenic temperatures is also shown for comparison.

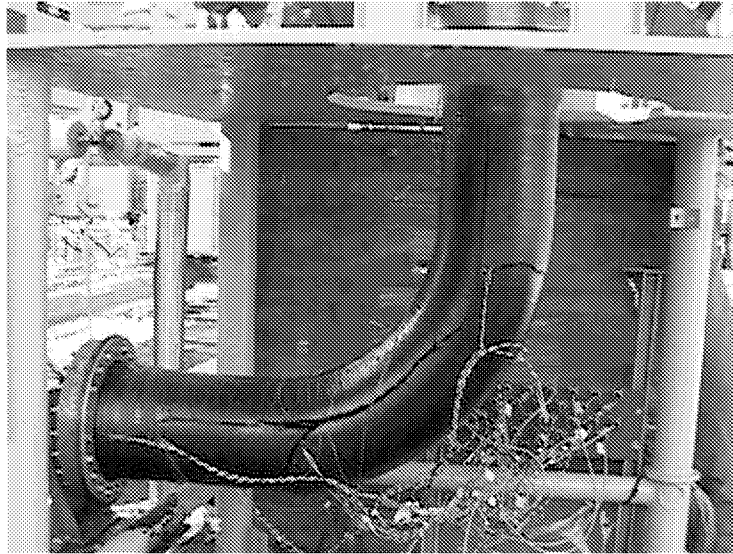
Figure 42. Feedline HLU-2 after failing at 545-psi internal pressure.

Feedline HLU-2 was hydrostatically tested for burst strength. The feedline was installed such that both flanged ends were rigidly fixed to prevent any movement. A maximum pressure of 545 psi was reached and then the feedline catastrophically failed. A photograph of the failed feedline is shown in figure 42. A longitudinal split is seen on most of the feedline with a radial split occurring about three quarters of the way up the tube.

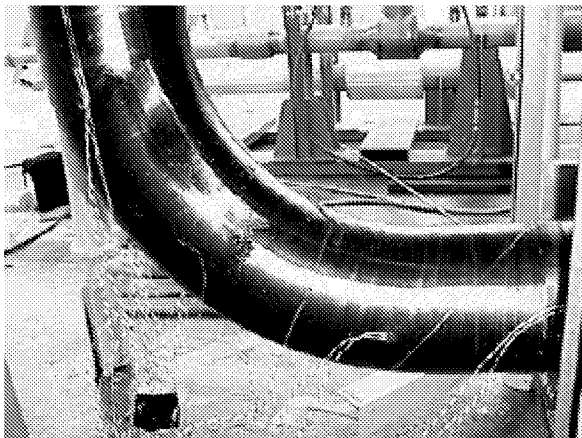
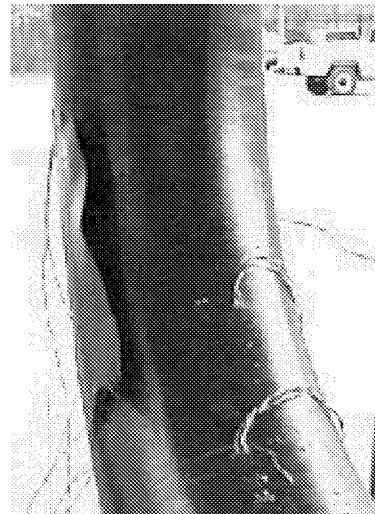
Figure 43. Feedline HLU-7 after failing at 364-psi internal pressure.

Feedline HLU-7 was then hydrostatically tested for burst strength. It was also installed such that both flanged ends were rigidly fixed to prevent any movement. A maximum pressure of 364 psi was reached and then the feedline catastrophically failed. Photographs of the failed feedline are shown in figure 43. A large split about one fourth of the tube length is seen along one side.

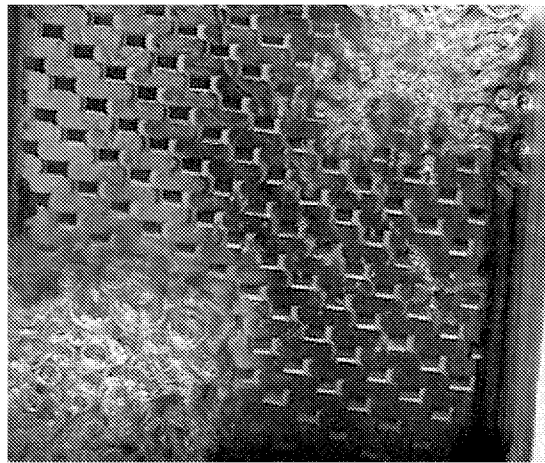
Specimen 6 showing leakage across certain areas of the laminate.

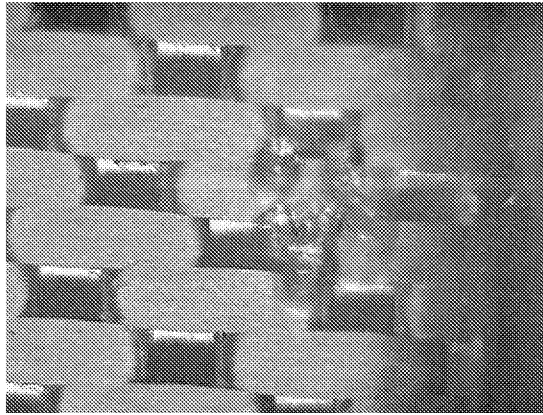
Close-up view of above specimen showing leakage at stitch.
